## Service Bulletin

**Number:** 1733  
**Date Issued:** 9-5-14  
**Product Affected:** G3 Visions  
**Reason For Bulletin:** OTP connectors coming loose  
**Serial Numbers:** ALL  
**Reference SCO:** n/a

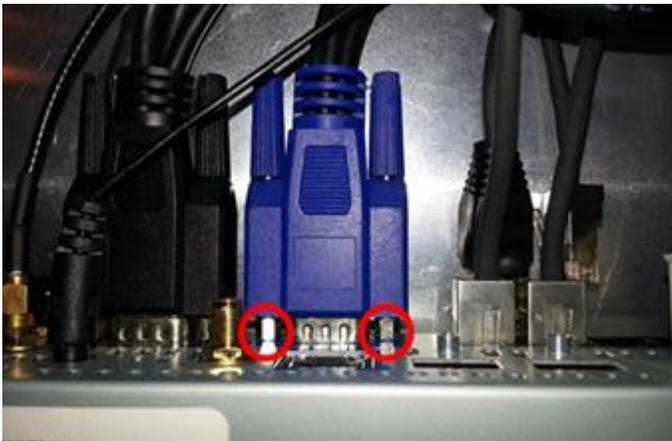
The two OTP connectors on the back of the G3 Vision (OTP1- black and OTP2 - blue) could come loose during operation in the field.

Recent events and symptoms experienced by a KSI Sales person with their Vision DVR led them to investigate other possible root causes with their DVR. The symptoms he experienced with his DVR had to do with getting a black screen during boot up. And this was an intermittent symptom on many occasions. The Sales person found the screws holding the OTP2 connector to the chassis had worked their way loose allowing for a loose connector which may have been the cause for their boot up issue. The connector was tightened and the cable reconnected and it has been working great ever since.

After talking with a KSI tech, it is very possible for the chassis nuts to work themselves loose when the cable connector is tightened and then loosened. When a very tight cable connector is

loosened it could loosen the chassis nut as well as they both turn the same direction when tightened and subsequently when loosened.

Make sure the “chassis” nuts on the OTP1 and OTP2 connectors that are part of the chassis are always tight.

After doing some research, we found the supplier was indeed using “blue” Loctite on these screws and had been for over a year (meaning all of 2014 and part of 2013). We will request that the supplier start using “red” Loctite for these screws going forward.

- 1) If OTP1 and OTP2 cables are connected, remove/disconnect them.
- 2) With the appropriate hex drivers, loosen the OTP1 and OTP2 connector screws.
- 3) Apply a dab of red Loctite.
- 4) Retighten the connector’s screws.
- 5) Reconnect the cables, if applicable.
